Title: Surveillance Report on SAVY 4000 and Hagan Nuclear Material Storage Containers Update for Fiscal Year 2019

Surveillance Report on SAVY 4000 and Hagan Nuclear Material Storage Containers Update for Fiscal Year 2019

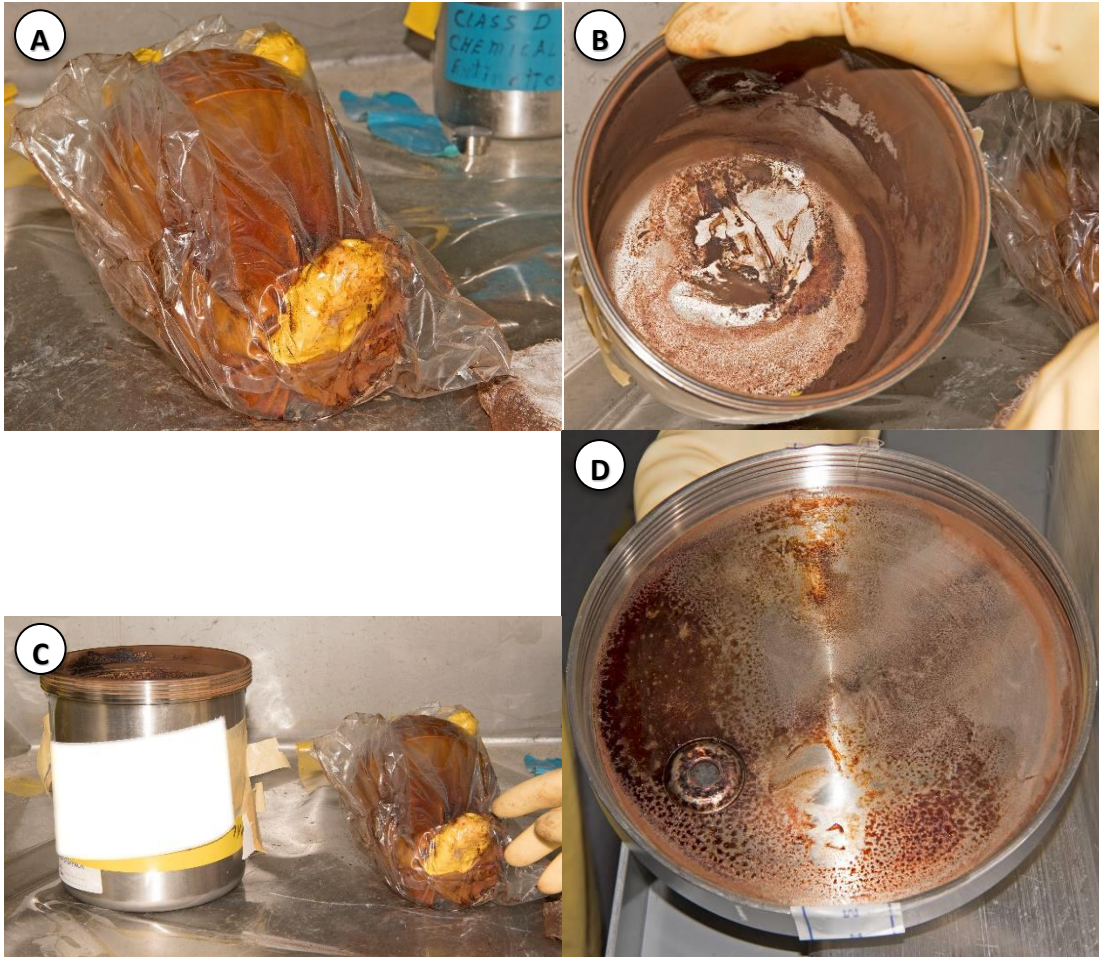
Figure 4-1 Visual inspection of 19H1. (A) Heavily degraded bag-out bag inside of non-PVC bag. (B) Deposits of corrosion products and evidence of bag-out bag residue. (C) Corrosion in the thread region of the Hagan clearly past the o-ring seal. (D) Heavy deposits of bag-out bag material.

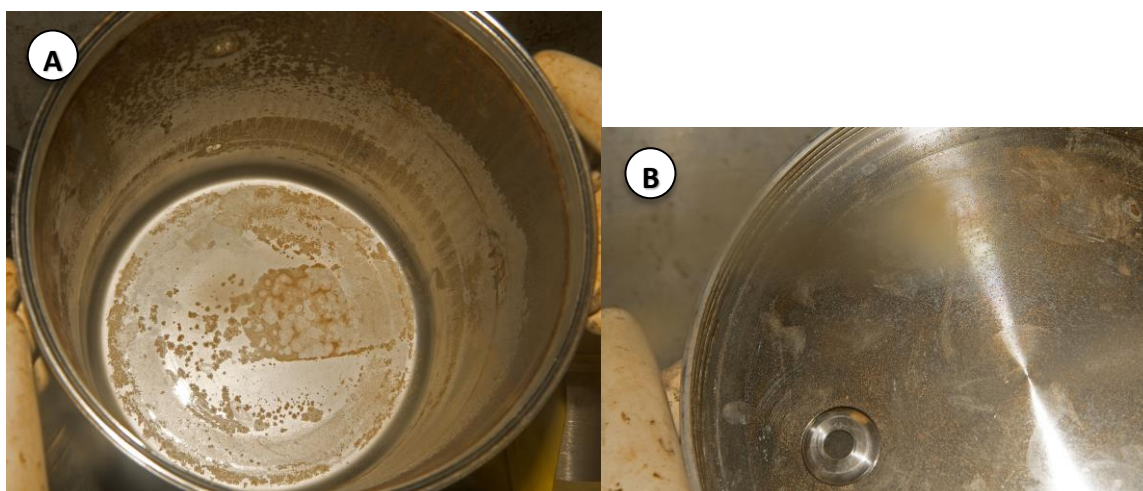
Figure 4-2 Visual inspection of 19H3 (A) Corrosion on inner surface of Hagan container. (B) Corrosion on the underside of the Hagan lid.

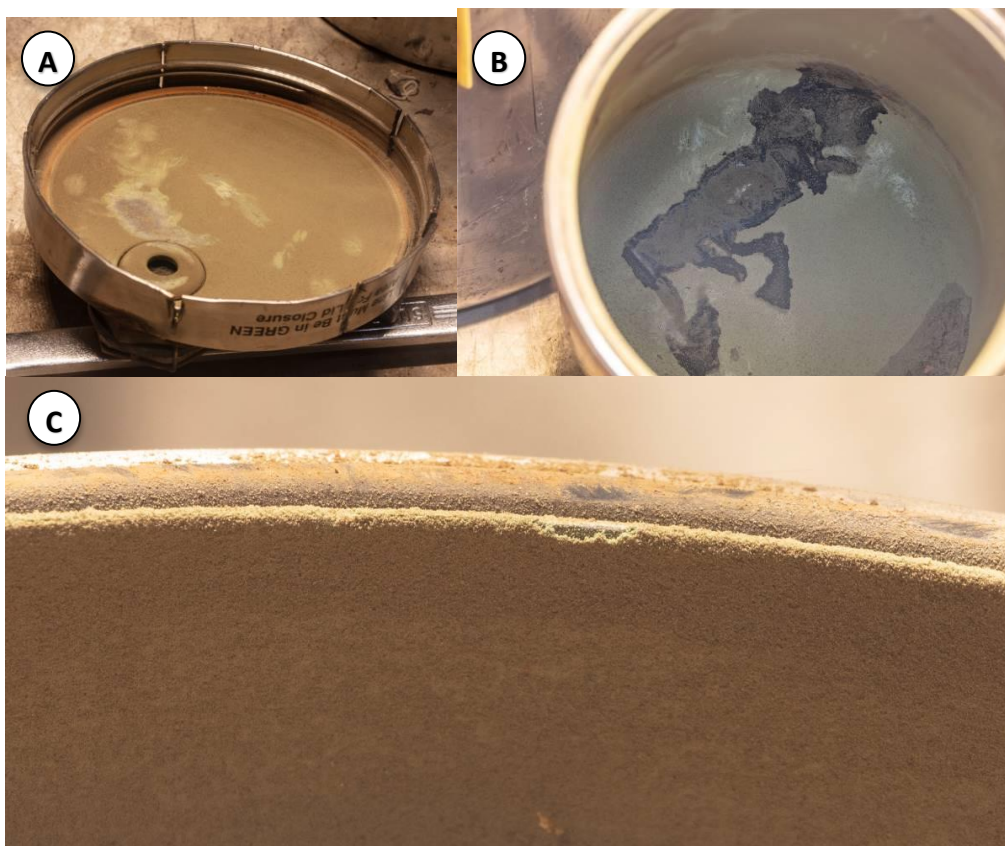
Figure 4-3. Photographs of 19H5 after it was opened inside of glovebox. (A) Internal surfaces of container 19H5 lid showing dry brown residue (B) Bag-out bag residue covering inside surface of the body.

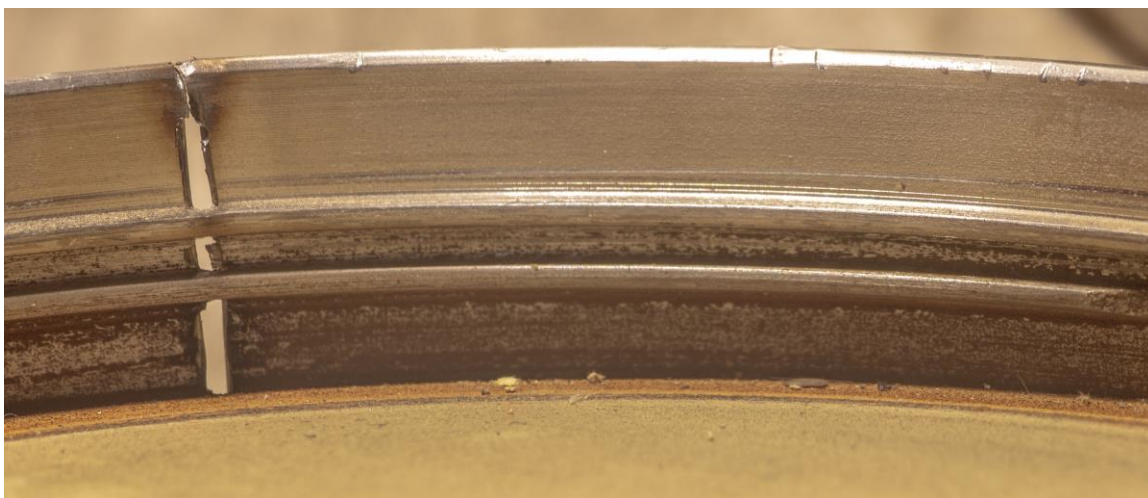
Figure 4-4. Image of 19H5 showing corrosion on threads.

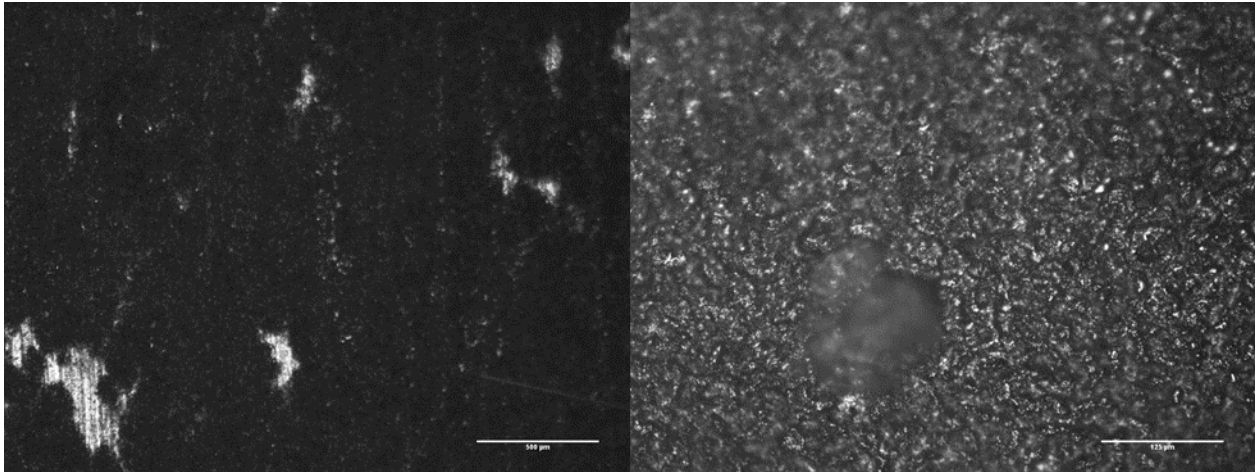
of stainless steel corrosion product and degradation product of the PVC bag. A section was removed from the sidewall for examination. The container parts were cleaned by wiping with DI water. Optical microscopy was performed on sections of the cleaned container lid and body. The lid shows mostly general corrosion and shallow pits. The pit depths (and diameters) could not be determined because much of the native surface was removed.

Figure 4-5 Hagan container 19H5 showing general corrosion and pitting on the lid (left) and sidewall (right)

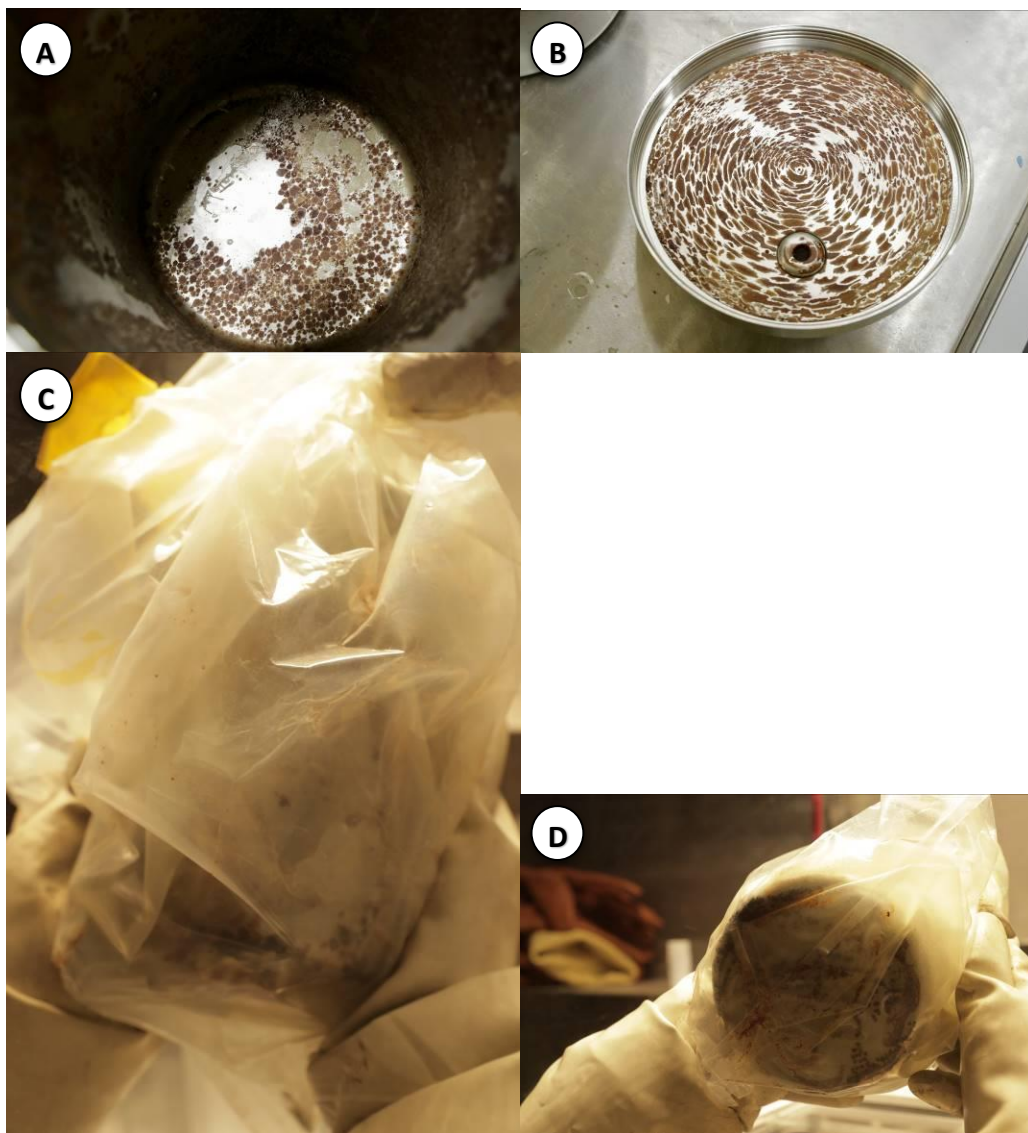
Figure 4-6 Visual inspection of 19H7 (A) Corrosion on inner surface of Hagan container. (B) Corrosion on the underside of the Hagan lid. (C) Non-PVC bag around inner container. (D) Evidence of corrosion on inner container surfaces.

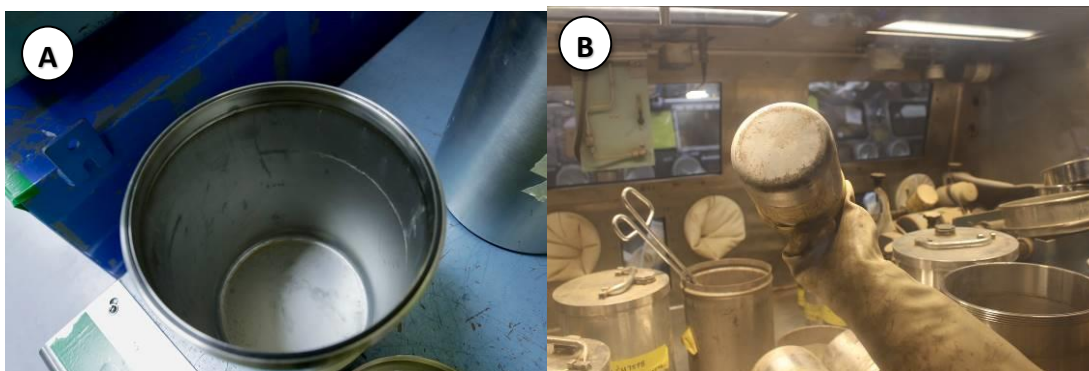
Figure 4-7 Visual inspection of 19loOP45 (A) No evidence of corrosion on the inner surfaces of Hagan 19loOP45. (B) Lite corrosion on inner container.

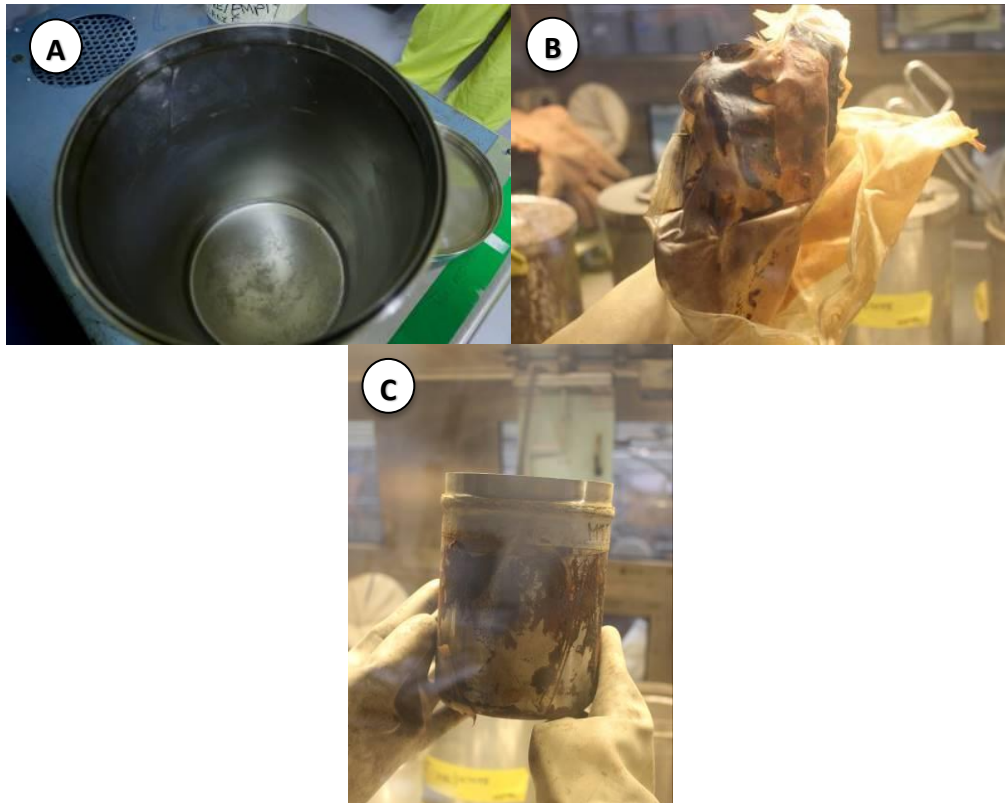
Figure 4-8 Visual inspection of 19IoOP46 (A) No evidence of corrosion on the inner surfaces of Hagan 19IoOP46. (B) Bag material has degraded and is beginning to become brittle. (C) Inner container is showing signs of corrosion.

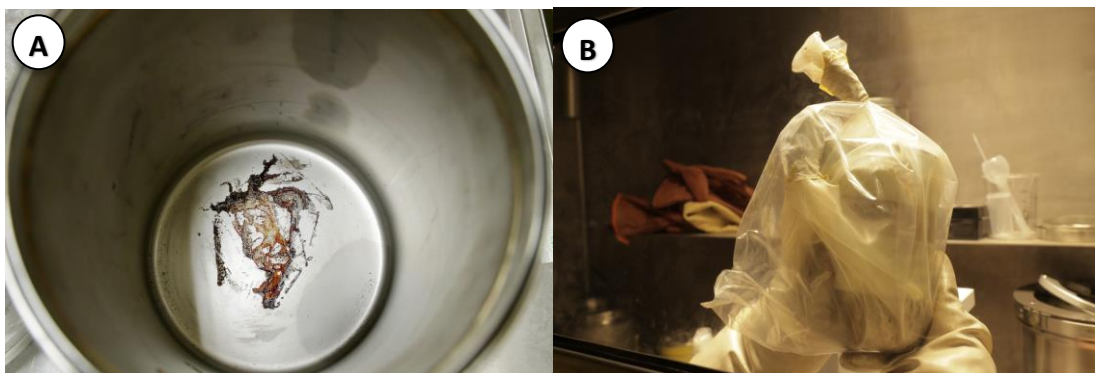
Figure 4-9 Visual inspection results of 19loOP50 during unpacking. (A) Residue found at the bottom of 19loOP50 from bag-out bag. (B) Non-PVC bag around PVC bag-out bag.

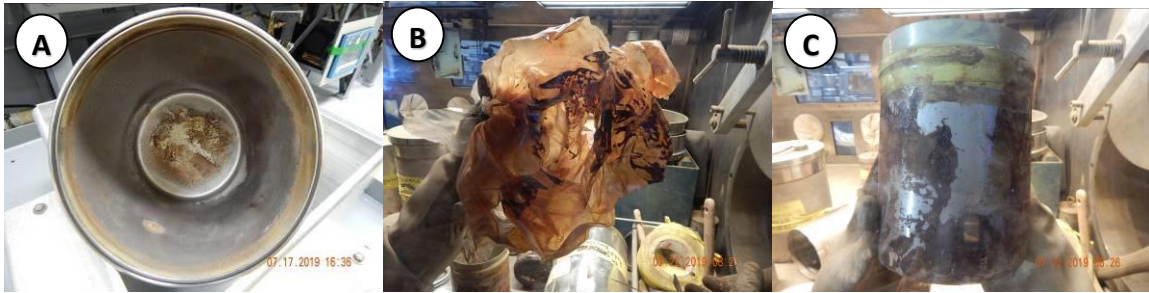
Figure 4-10 Visual inspection results of 19IoOP55 during unpacking. (A) Residue found at the bottom of 19IoOP55 from bag-out bag. (B) Bag-out bag is showing signs of degradation and has turned dark. (C) Signs of corrosion and evidence of bag residue on inner container.

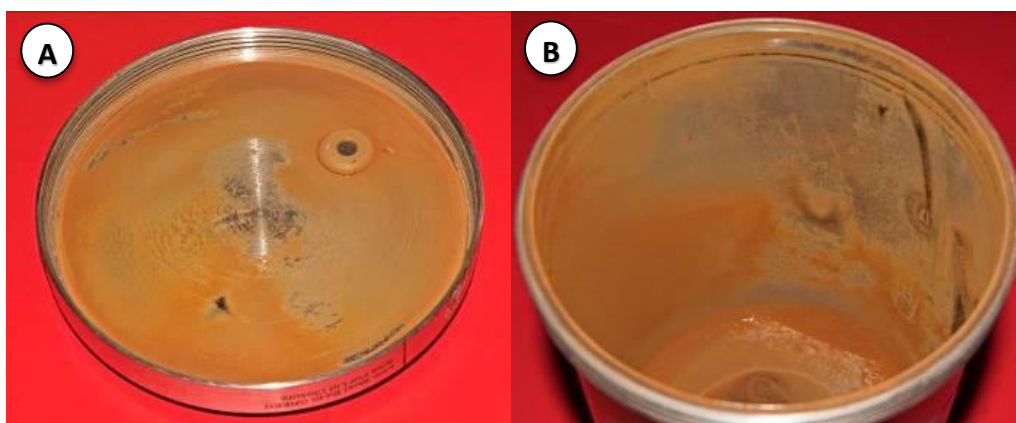
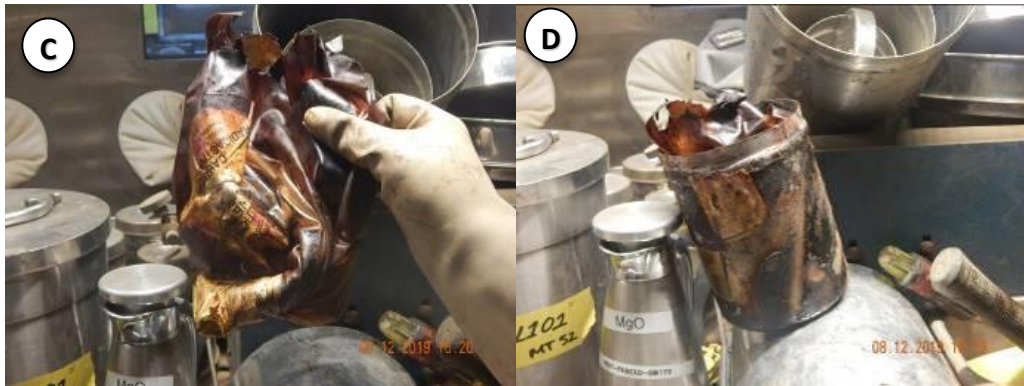
Figure 4-11 Visual inspection results of 19IoOP56 during unpacking. (A) General corrosion on the lid of 19IoOP56. (B) General corrosion on the body of 19IoOP56. (C) Heavily discolored and degraded bag-out bag from 19IoOP56. (D) Condition of inner container with corrosion.

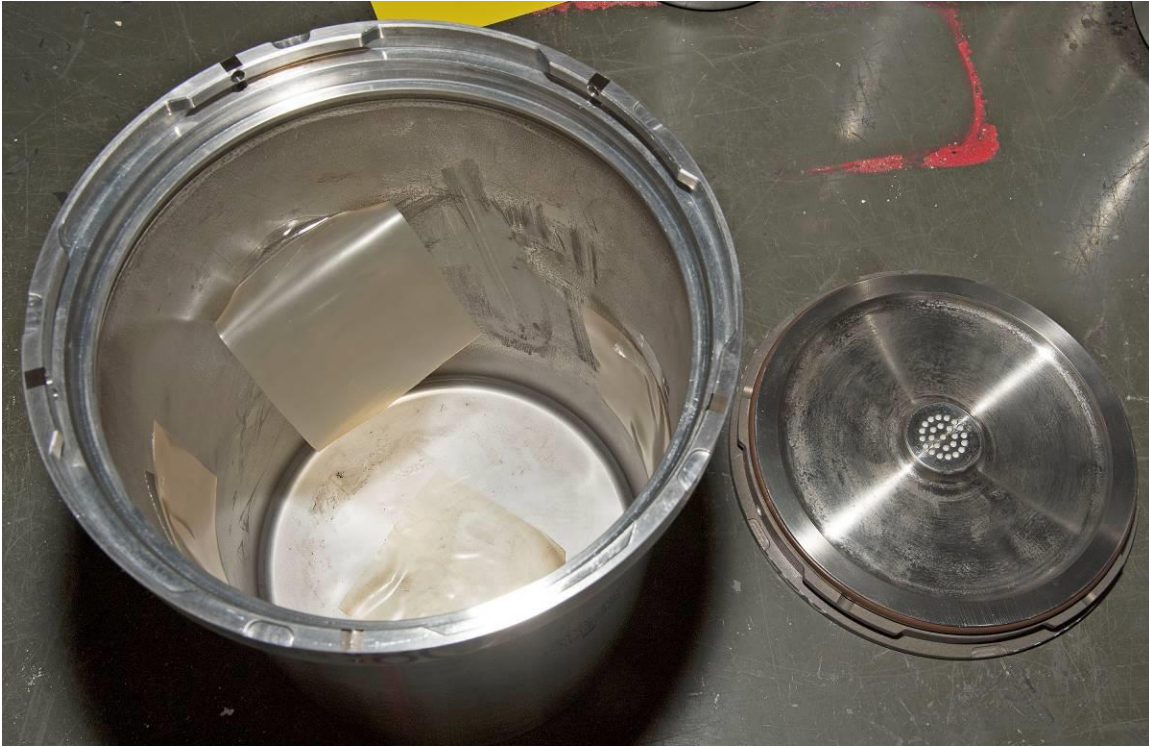
There is residue around the inside wall of the container (Figure 4-16) and corrosion around the weld inside the container (Figure 4-17). The O-ring passed the visual inspection, but did have small inclusions but not enough to comprise the seal. The bag-out bag was reported in good condition.

Figure 4-16. Alternate bag-out bag sample in 19S1.

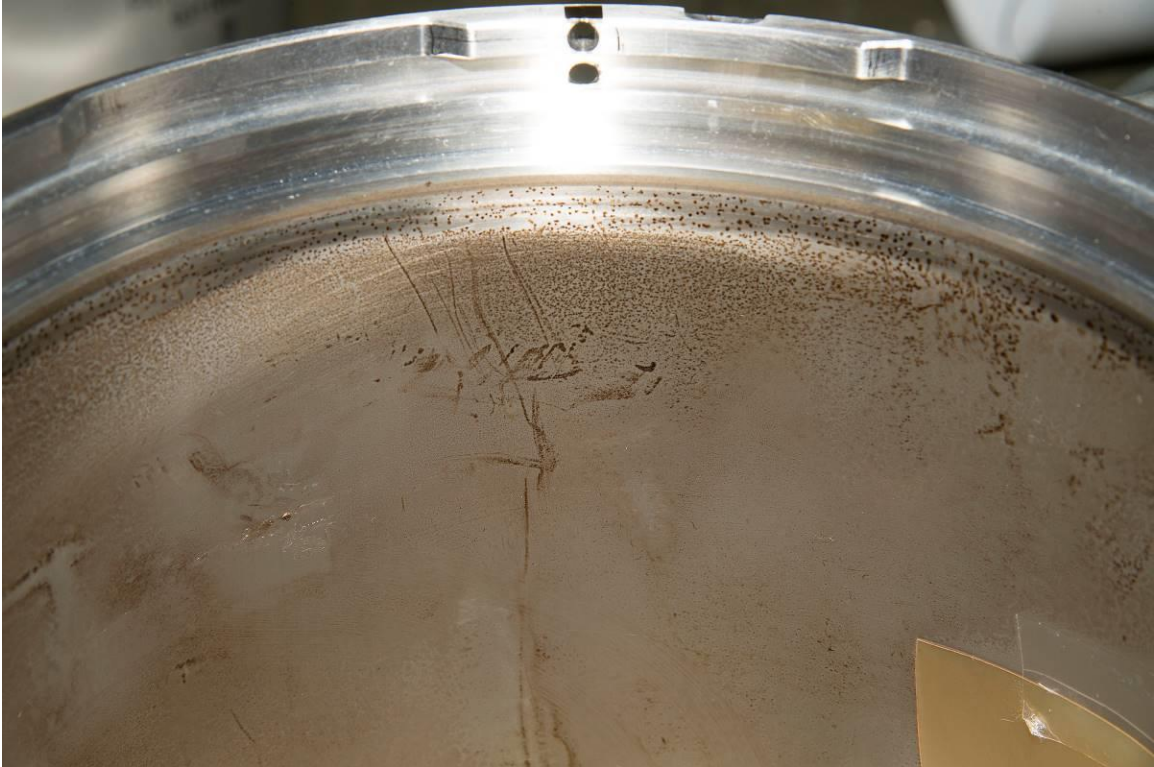
Figure 4-17. Corrosion around weld in 19S1.

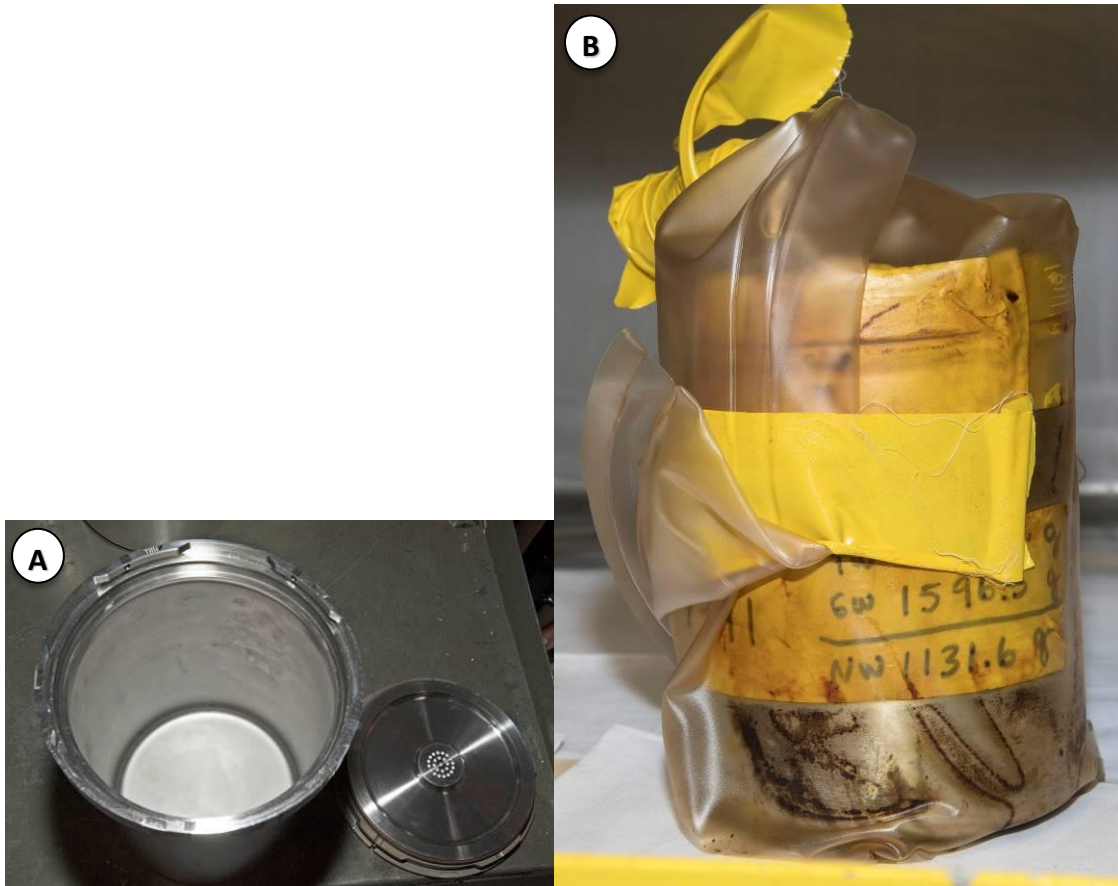
Figure 4-18 Visual inspection results of 19S2 during unpacking. (A) Inside surfaces of 19S2 that is showing no signs of corrosion. (B) Bag-out bag around item in 19S2 showing minor signs of degradation.

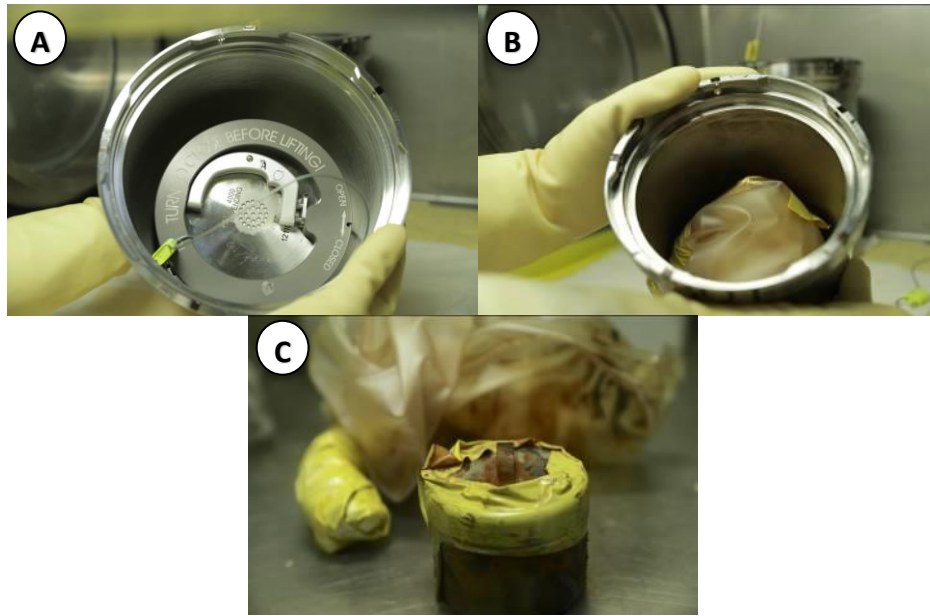
Figure 4-19 Visual inspection results of 19S3 during unpacking. (A) Evidence of white residue near the filter of 19S3. (B) There is some corrosion found on the inner surfaces of 19S3 and a bag that “appears” to be in good shape. (C) Corrosion can be found on the inner container.

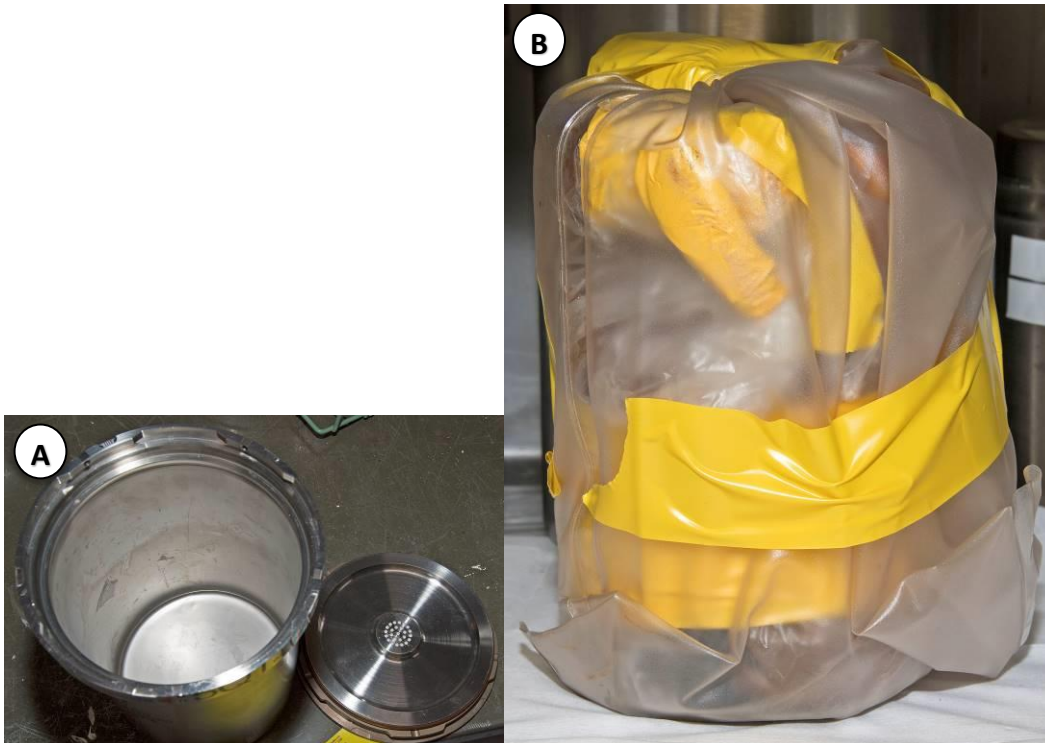
Figure 4-20 Visual inspection results of 19S4 during unpacking. (A) Some bag residue was found on the inner surfaces of 19S4 with no evidence of corrosion. (B) Two or more bags have been used as contamination control around the inner container.

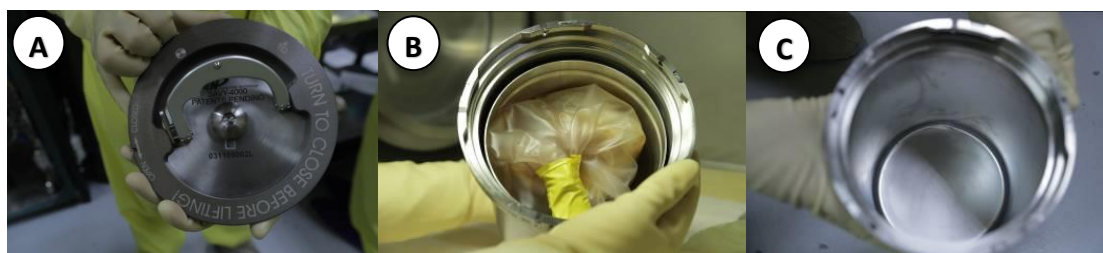
Figure 4-21 Visual inspection results of 19S6 during unpacking. (A) The hermetic cap on 19S6 appears to be in good condition. (B) The bag inside of 19S6 is starting to discolor slightly. (C) Some bag residue was found on the inner surfaces of container 19S6.

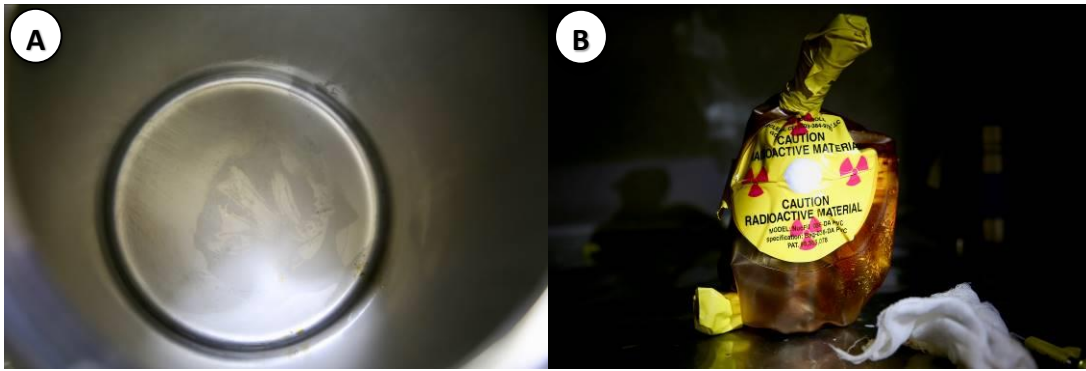
Figure 4-22 Visual inspection results of 19S9 during unpacking. (A) Liquid bag residue is seen in the bottom of 19S9. (B) Bag-out bag is heavily discolored.

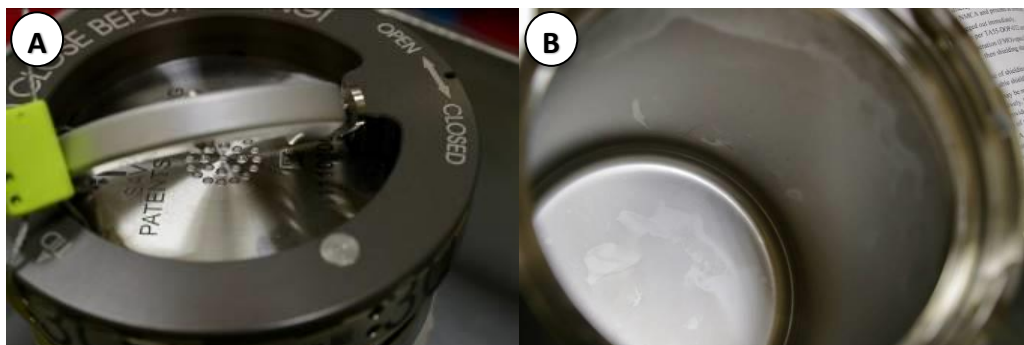
Figure 4-23 Visual inspection results of 19S10 during unpacking. (A) No evidence of white residue on the outside of the filter. (B) Some bag residue can be seen on the inside surfaces of 19S10.

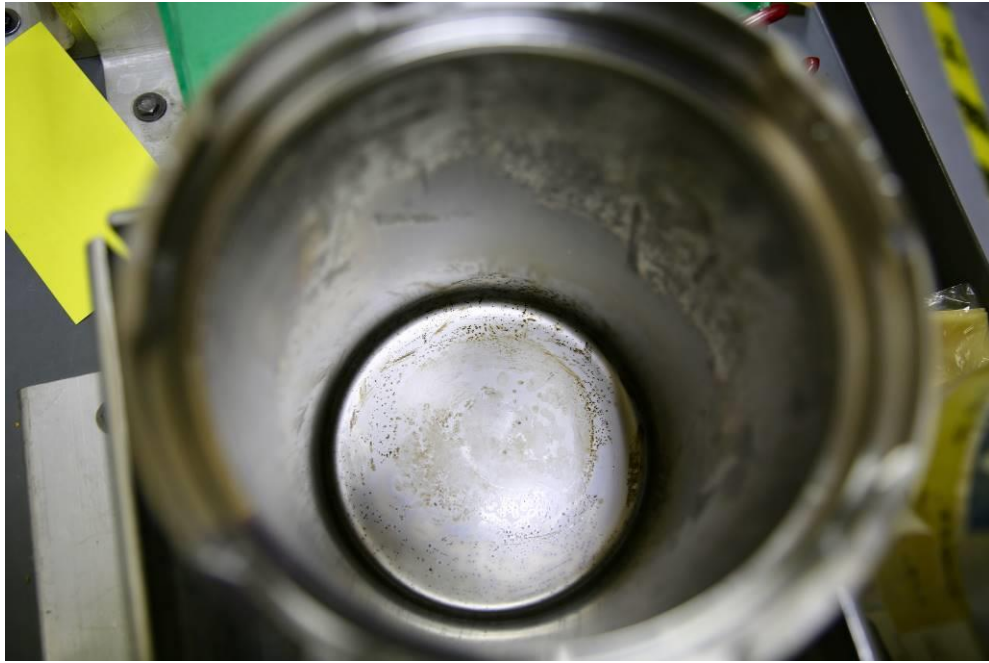
Figure 4-24 Visual inspection results of 19S11 during unpacking. Areas of corrosion on inner surfaces of 19S11

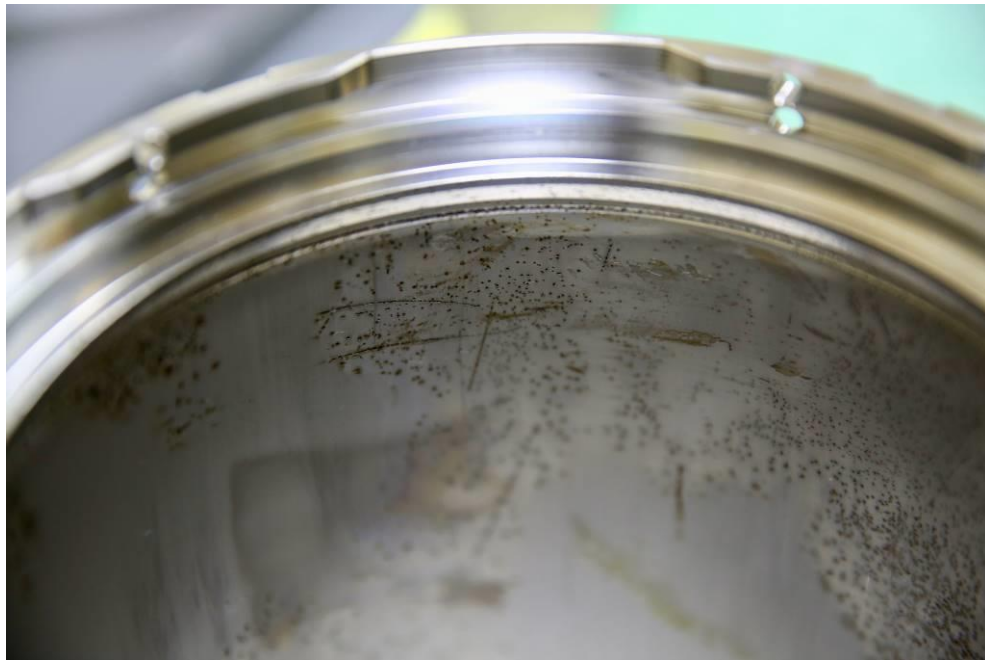
Figure 4-25 Visual inspection results of 19S11 during unpacking. Corrosion on inner surfaces of 19S11.

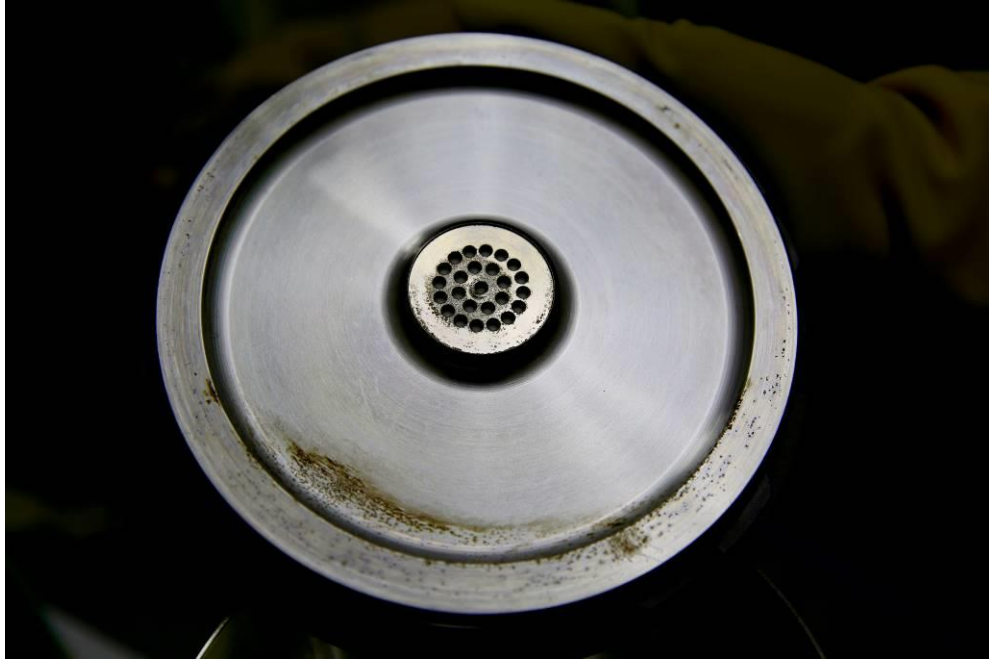
Figure 4-26 Visual inspection results of 19S11 during unpacking. Corrosion on underside of lid of 19S11.

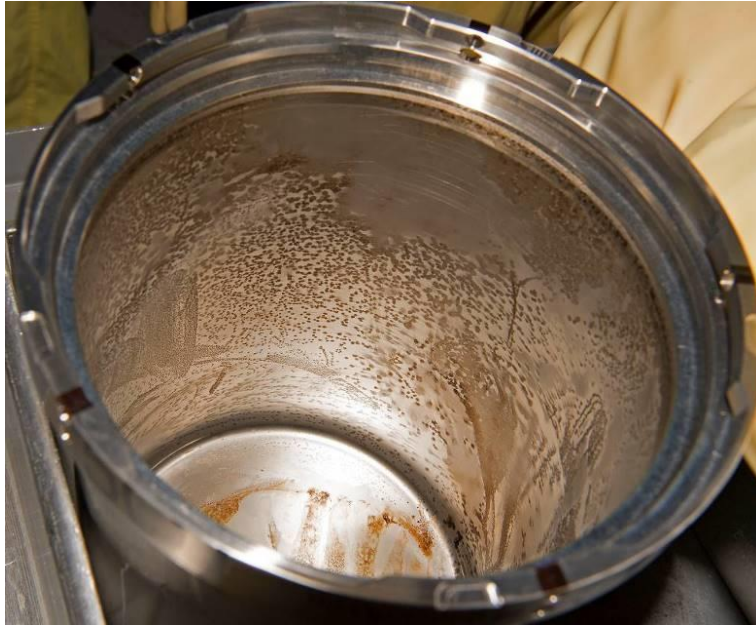
Figure 4-27 Visual inspection results of 19S13 during unpacking. Corrosion can be seen covering a large portion of the inner surfaces of 19S13 with areas of native metal surrounding them.

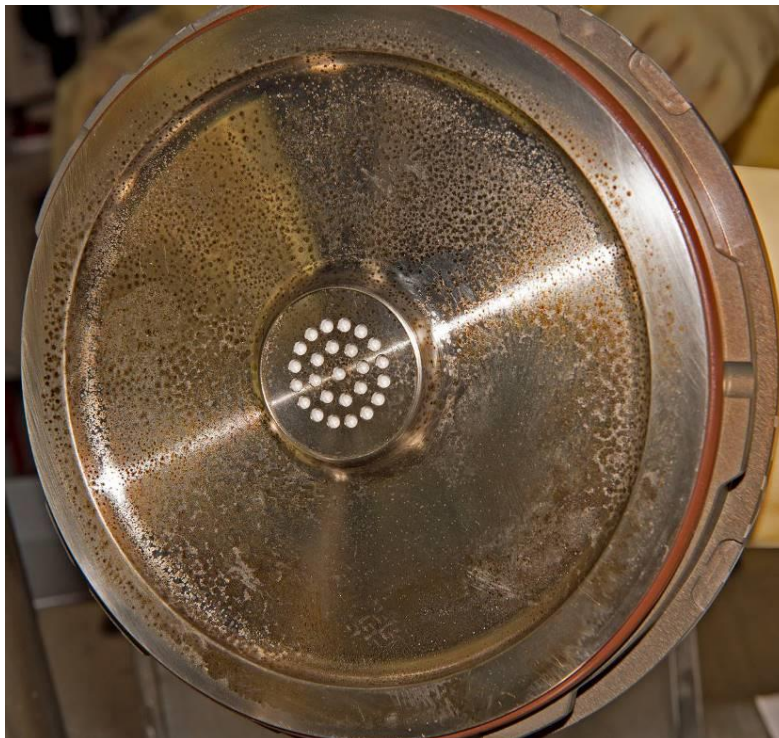
Figure 4-28 Visual inspection results of 19S13 during unpacking. The underside of the lid was found to have a considerable amount of corrosion.
